Name of Dam: Mays Dam

Location: Amherst County, State of Virginia

Inventory Number: VA 00909

PHASE I INSPECTION REPORT
NATIONAL DAM SAFETY PROGRAM

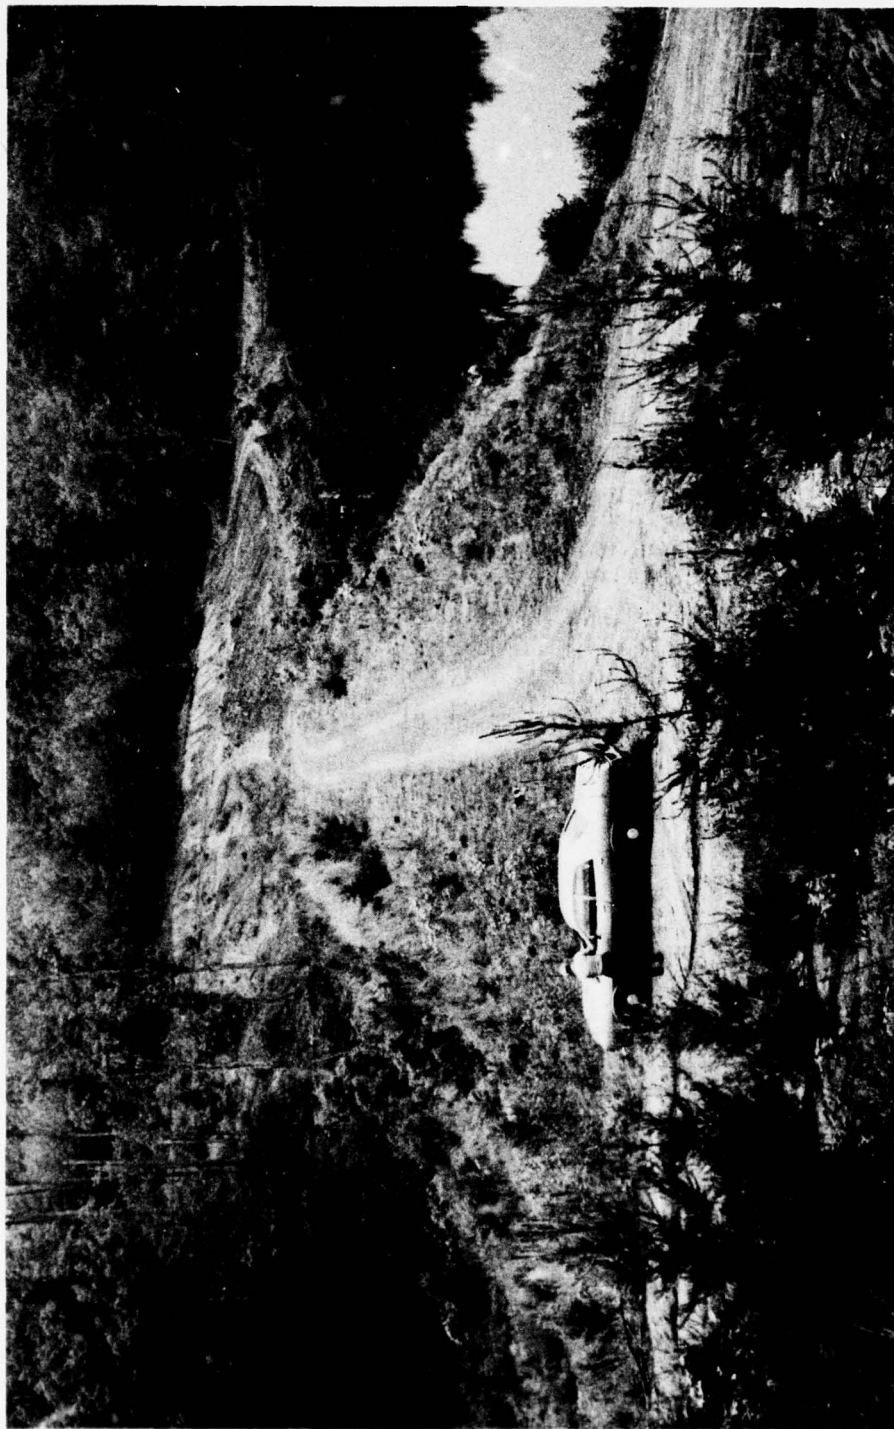
OVERALL VIEW OF DAM

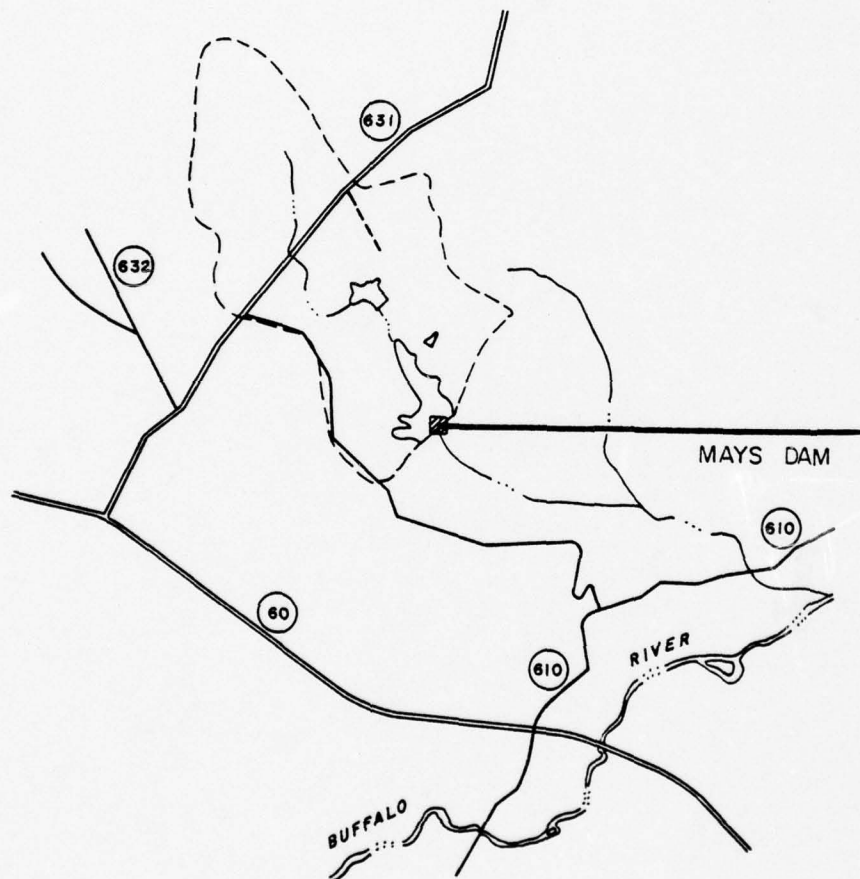
MAYS DAM
Michael Baker, Jr., Inc.
July 1979
PLATE I

- 3.1.1 General: The field inspection was made on 23 May 1979 when the reservoir was at normal pool elevation. The weather was cloudy and warm with the temperature at 78°F and ground conditions were dry. The embankment and appurtenant structures were found to be in fair condition at the time of inspection (see Plate 1 and Photos 3 and 4). The following are brief summaries of deficiencies found during the inspection. A Field Sketch of conditions is shown as Plate 1. The complete visual inspection check list is given in Appendix III.

- There is a spring with a flow of 1 g.p.m. from the hillside near the left abutment of the dam. The spring does not appear to affect the embankment (see Plate 1). There are some bare and eroded areas on the hillside at the left abutment (see Photo 2).

FIELD SKETCH
